Inspection Report

Mine Name: Alta Helena

Permit number: Assigned
S0350034 (Unpermitted)

Inspection Date: June 29, 2007
Time: about 9:45 to 10:30 AM

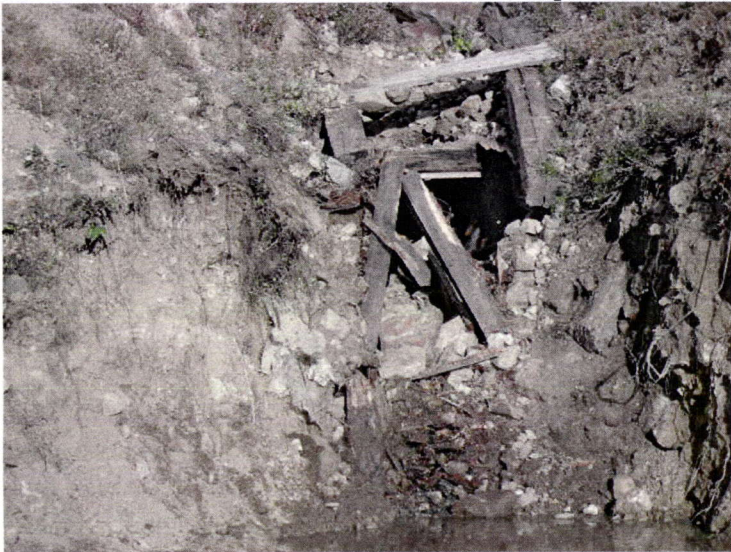
The site is in the Albion Basin within the area of the Alta ski resort. According to verbal information and photographs the Division has received, Mr. Melville cleared some material from in front of a historic mine portal and has built a structure extending about 20 feet from the entrance (Photos 1-3). I believe Photos 1 and 2 were taken October 15, 2004. There is a metal frame covered, at least on the top, with metal sheeting. Rock walls have been built on either side of the opening which has a locked wooden door. Dirt and rock cover most of the top of the structure, but there is a small gap between the back of the roof of the structure and the old mine portal.

Photo 1. This picture and Photo 2 were apparently taken October 15, 2004, and show the historic portal opening.

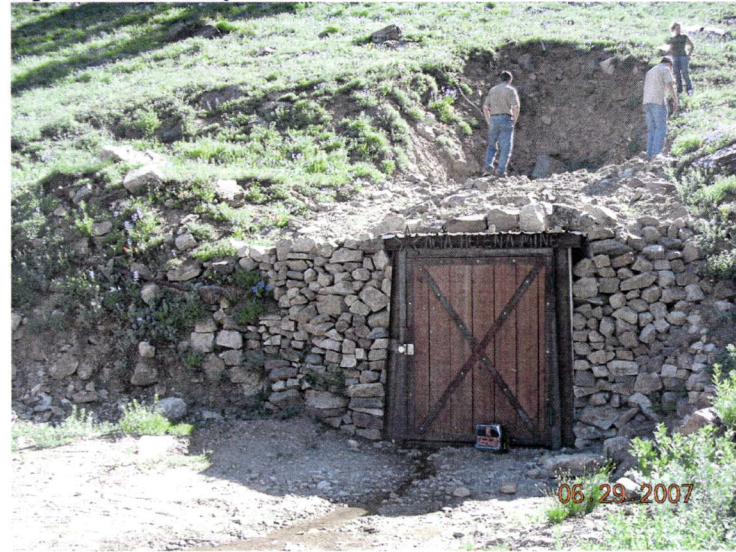
As shown in Photo 3, there was a small stream of water coming from under the door.

Photo 3. This shows the structure that has been built in front of the mine opening. Note the small highwall remnant in the upper right portion of the picture.

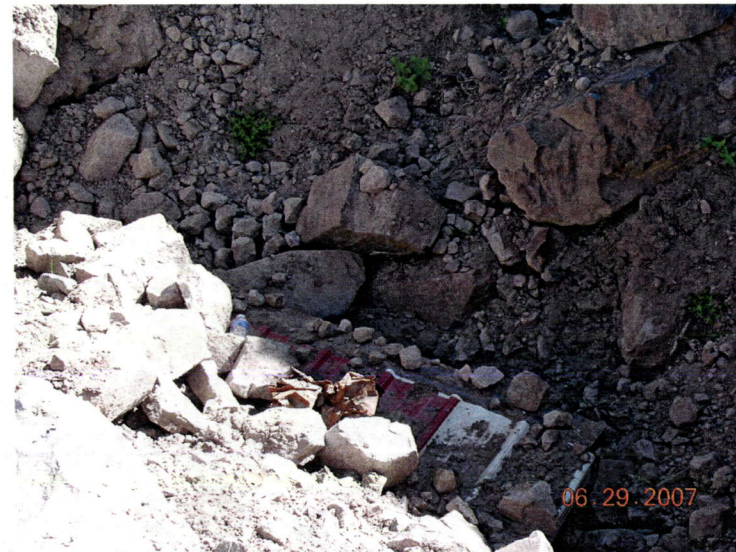
Considering the proximity of this site to heavily used recreation areas, I recommend that additional work be done to secure the opening to the mine. As mentioned above, there is a small gap between the structure Mr. Melville has built and the mine opening, and it would not be hard for a person to dig this out and possibly enter the mine. I do not know the condition of the mine and what hazards might exist.

Photo 4. There is a small gap between the newly-built structure and the highwall.

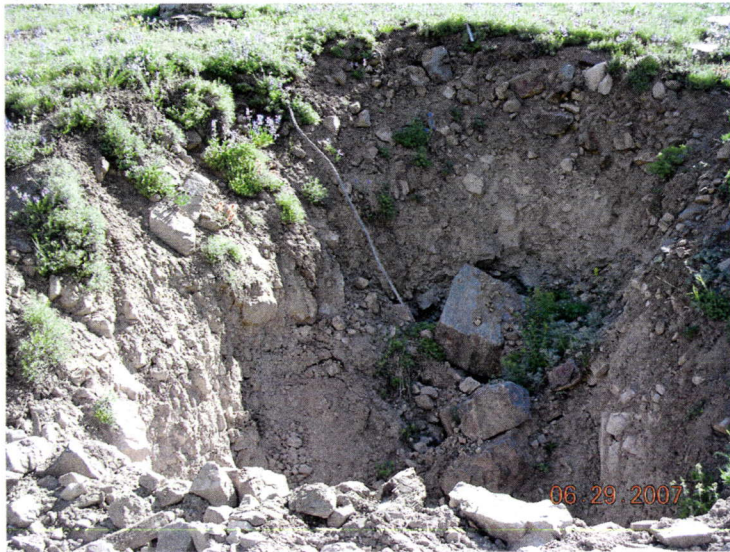
Photo 5. The highwall above the historic mine.

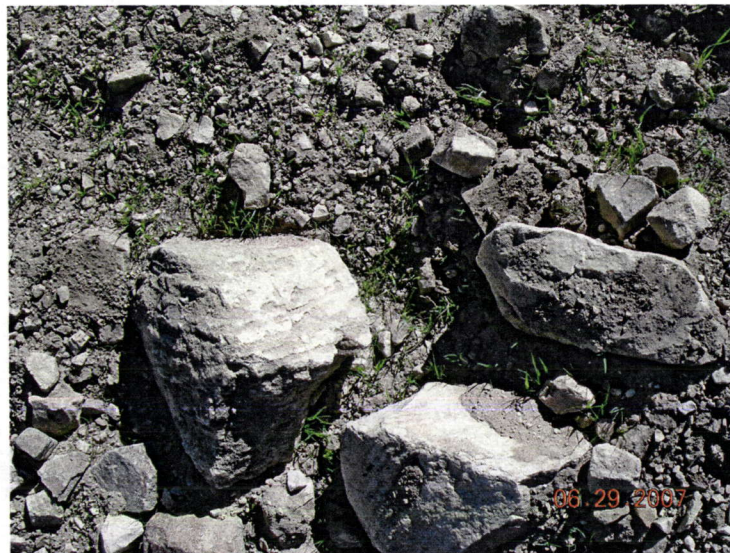
We found numerous grass seedlings growing on the pad in front of the portal (Photo 6), but I did not see any on the outslope (Photo 7). It is too early to determine what species are present. I understand this seeding was done by the Alta ski resort.

Photo 6. Seedlings on the pad in front of the mine.

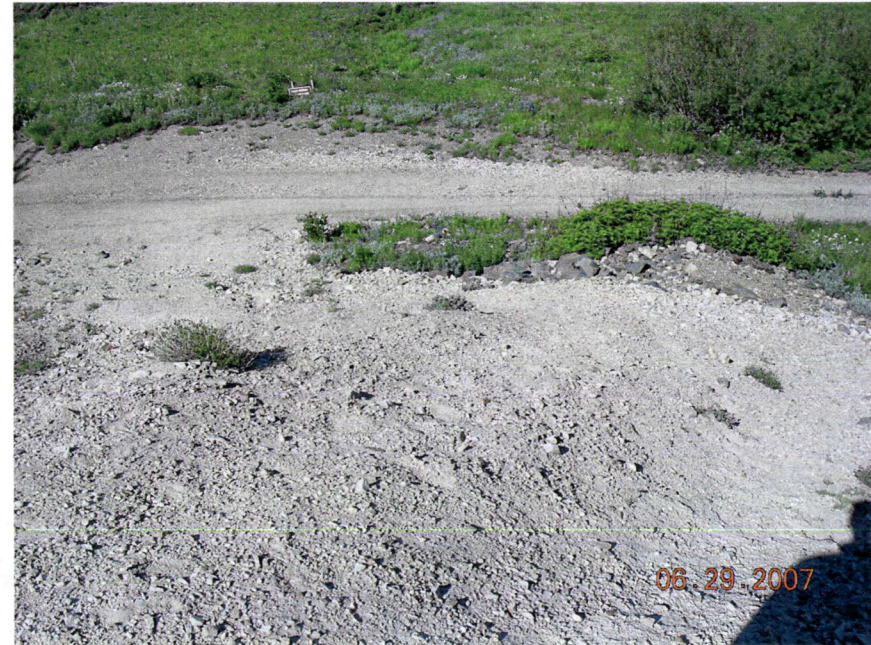
Photo 7. The pad outslope.
